CONNECTICUT RIVER BASIN
WHATELY, MASSACHUSETTS

SOUTH DEERFIELD
MA 00522

PHASE I INSPECTION REPORT
NATIONAL DAM INSPECTION PROGRAM

JUNE 1979

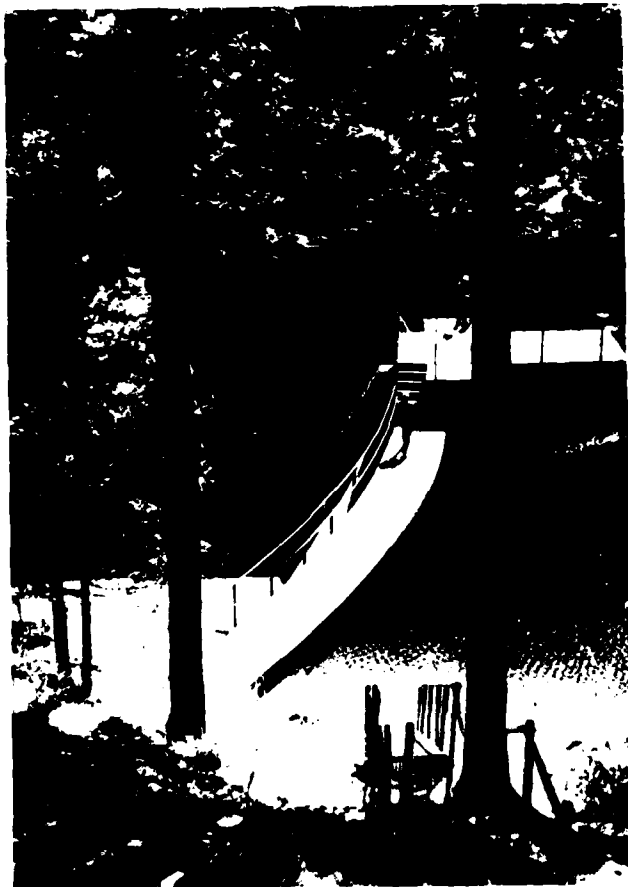
The upstream face was almost entirely under water at the time of the inspection, photo 4. According to sketches of the dam in past inspection reports, the upstream faces of the spillway and non-overflow section are both sloped at 3/4H:12V. The vertical crack in the downstream face of the non-overflow section (described in the Downstream Face) continues across the crest and down into the upstream pool. The upstream face of the main spillway could not be observed through the water surface.

PHOTO NO. 4 - Overall view
of crest from left abutment

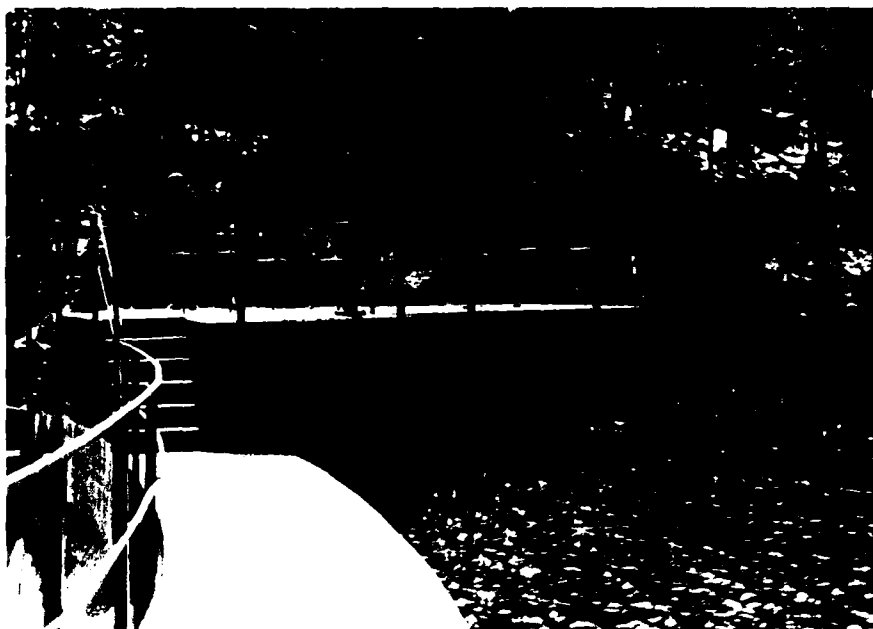
The general condition of the intake structure which could be observed above the water line, was good. The caretaker operates all gates regularly and they appear to be in working order.

PHOTO NO. 8 - Intake structure and controls viewed from left abutment.
